CARR-1453
2911 Bird View Road
Gamber (vicinity)

Maryland Historical Trust State Historic Sites Inventory Form

Survey No. CARR-1453

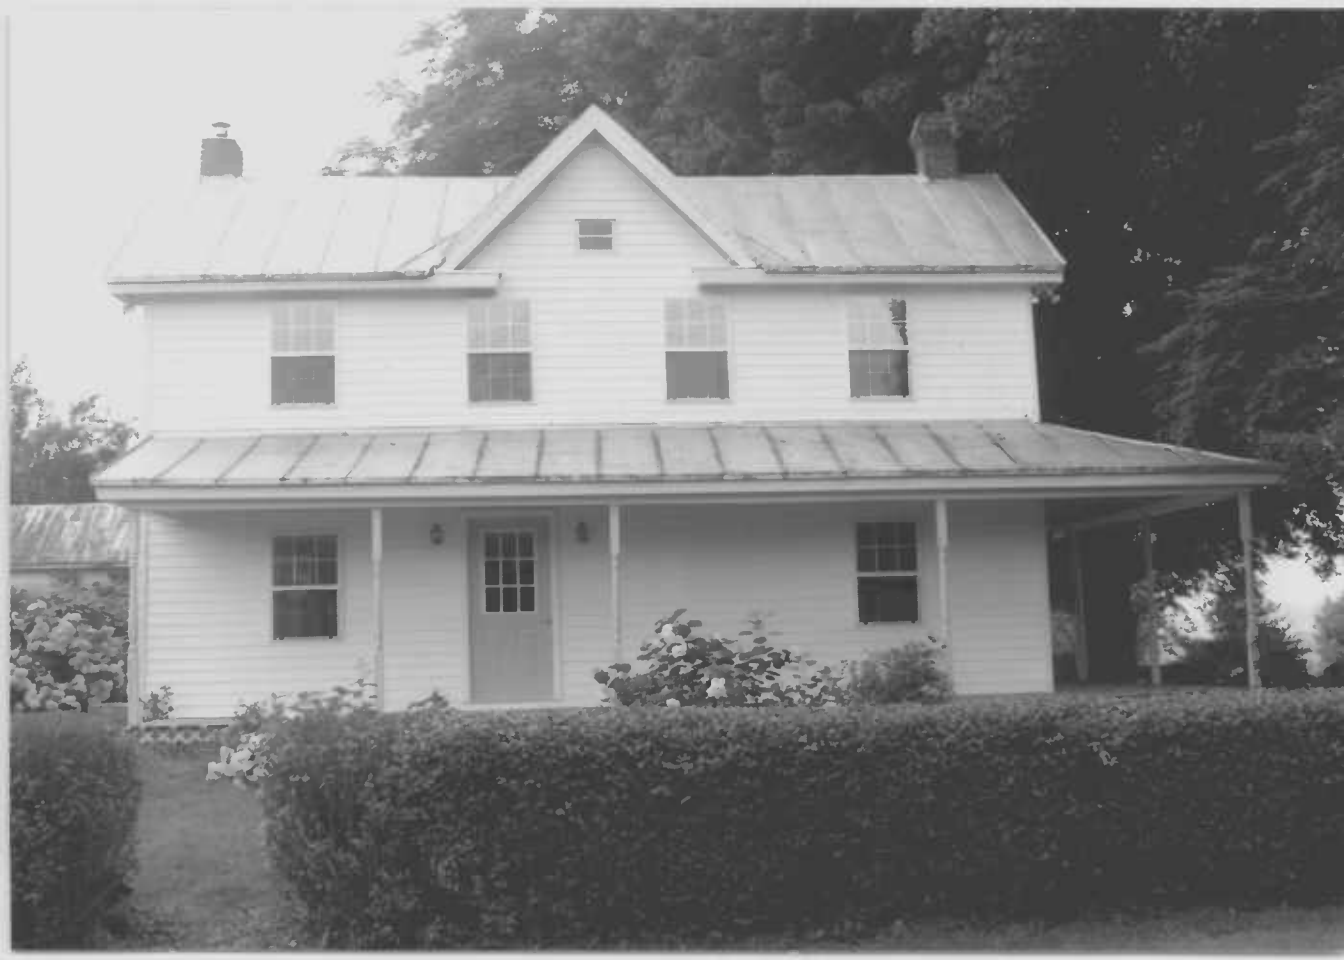
1/3

The house is a 2½-story, four-bay by two-bay, T-plan structure with a rubble stone foundation, aluminum siding, and a standing seam metal gable roof with an east-west ridge. The house faces north toward the street, and was apparently originally a Pennsylvania farmhouse plan, as the first-story has from east to west a window, a door, no opening, and a window. The windows in this house are all new 6/6 sash, and the doors are also new. There is an interior brick chimney on each end. There is a one-story, shed-roof porch with standing-seam metal on the north elevation, and it wraps around on the west. The porch has turned posts. The ell appears to have had a projecting pantry on the east elevation, with a porch between it, but this is now infilled. There is a new one-story enclosed room in the southwest crook, or re-entrant angle, of the T. There is an interior brick chimney on the south elevation of the ell.

Neg. Loc.: Maryland Historical Trust
house - N. elev.

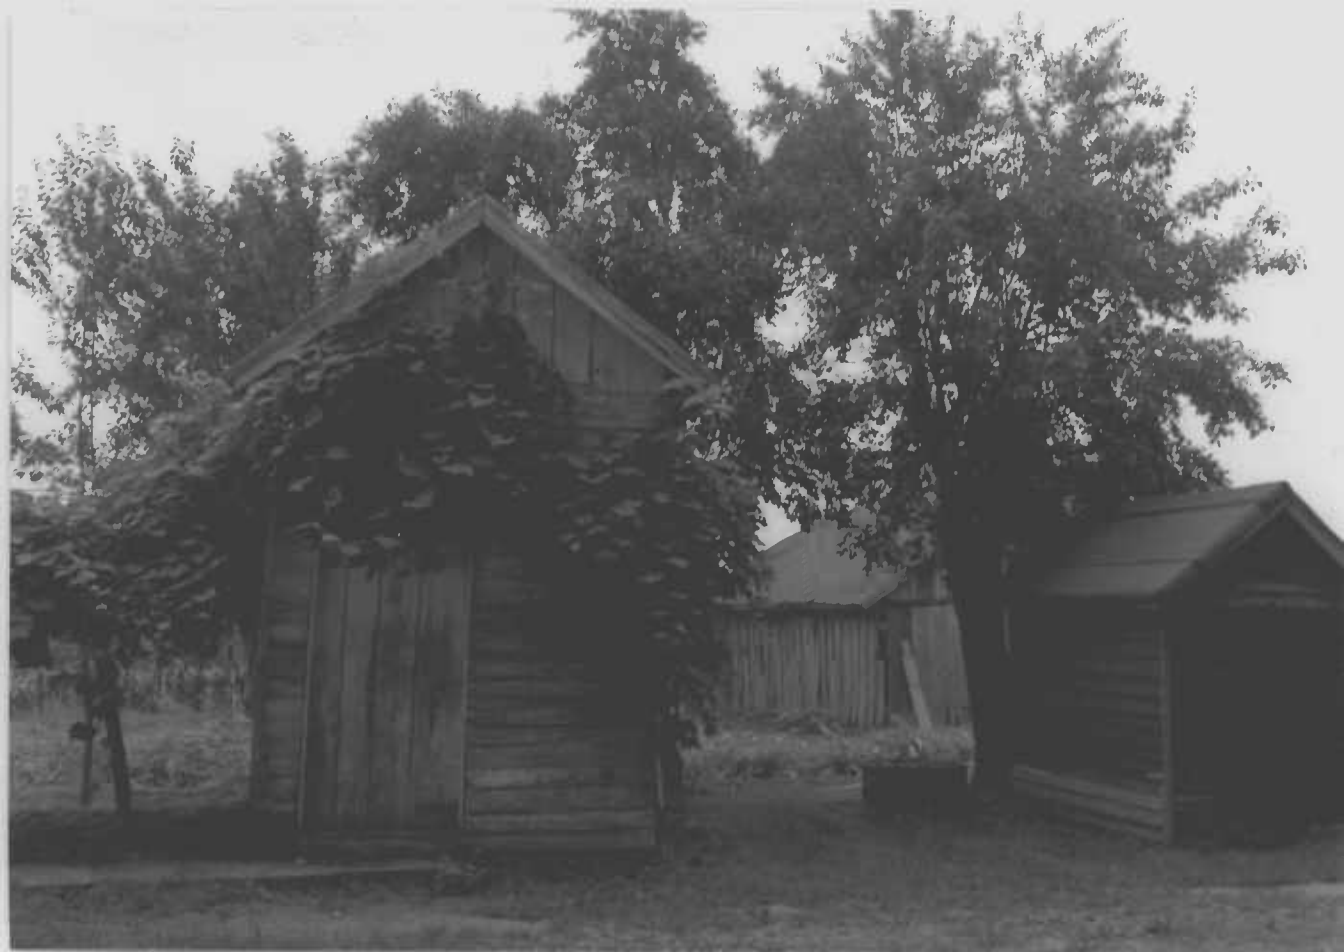
2/3

About 10 feet southeast of the house is a circular-sawn 2 x 4 shed. It is a one-story, one-bay square building with a mixture of weatherboards and German siding. It has a gable roof with an east-west ridge and inverted V-seam metal. The west elevation has a vertical-board door and the north elevation a four-light sash. On the interior, part of the walls are sheathed with horizontal tongue-and-grooved boards, and there are stairs along the east wall that lead to the upper story. There is a smokehouse that is one story and one-bay square. It has German siding and weatherboards, and a gable roof with asphalt roll roofing and an east-west ridge. The west elevation has a vertical-board door. The smokehouse is built of 2 x 4 circular-sawn timber with rafters that are mitered at the ridge.

2911 Birdview Rd.
Carroll County, Maryland
Photo: Matt Hankins
Date: July 1995
Neg. Loc.: Maryland Historical Trust
Shed: Smokehouse w. elevs.

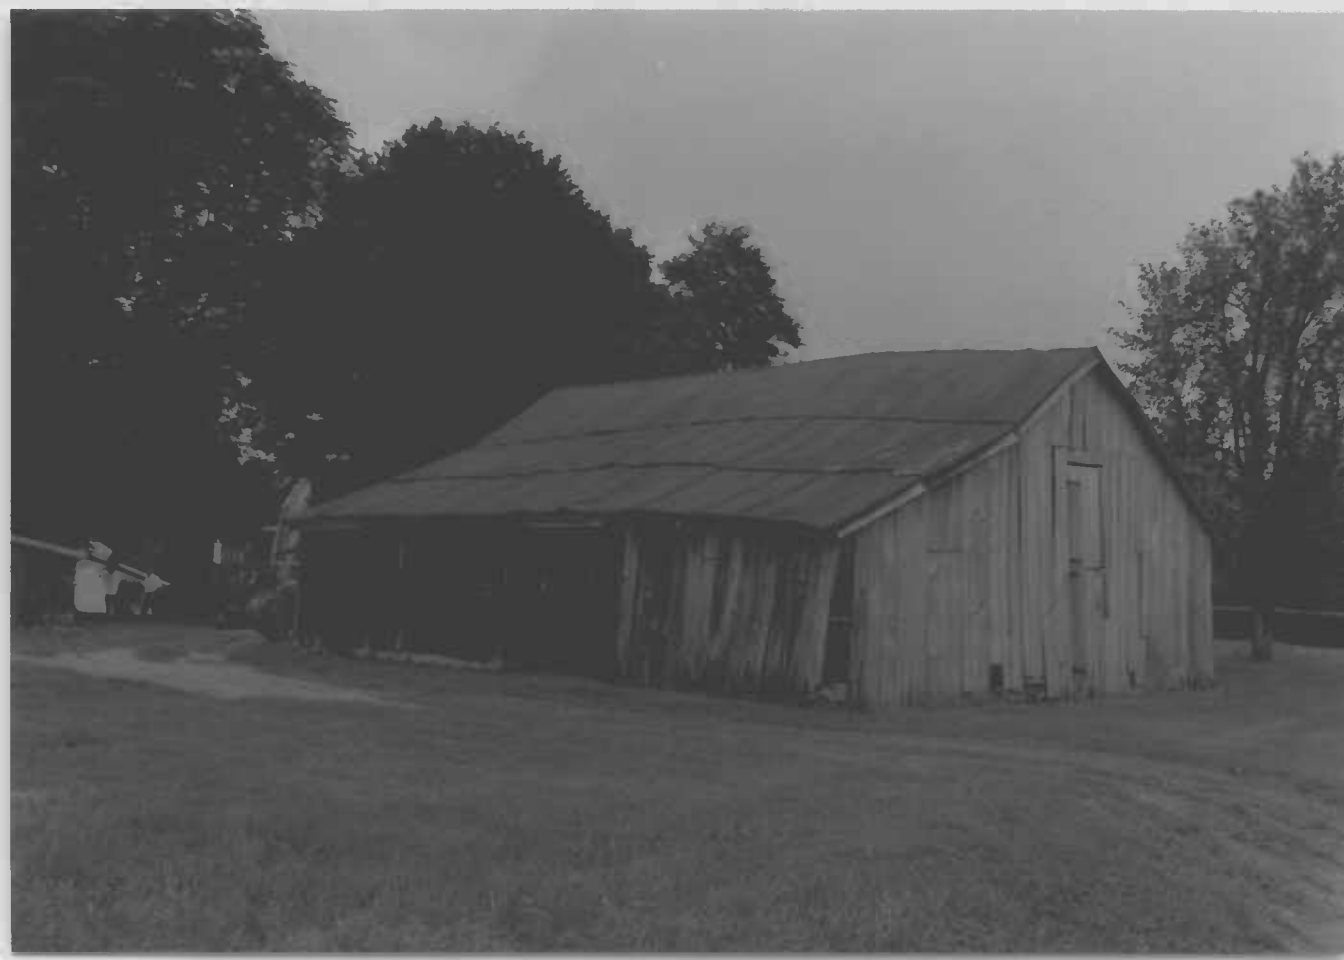
3/3

About 30 feet east of the smokehouse is a ground barn with vertical-board siding and a gable roof of inverted V-seam metal with an east-west ridge. The west elevation has a wagon door on strap hinges and a second one on butterfly hinges, with several doors to the south. The south elevation has three dutch doors on strap hinges. The north elevation has a wagon door on strap hinges at the east end. The barn has been added onto in several periods. The original section is the center and west two bays and is built with a mortised-and-tenoned-and-pegged, circular-sawn frame. On the east end, the center and north bays were added, and were also built with a mortised-and-tenoned-and-pegged, circular-sawn frame. The whole south end of the building was added all at one time and the northwest corner of the building appears to have been added last. It has a circular-sawn 2 x 4 frame.

barn-south; east elevs.
